THIS SHEET INCLUDES FITTING INSTRUCTIONS FOR THE FOLLOWING PARTS:

Secondary Alternator Cover Part No. EC-RS660-2021-1-GBR / Secondary Clutch Cover Part No. EC-RS660-2021-2-GBR /
 Secondary Water Pump Cover Part No. EC-RS660-2021-5-GBR

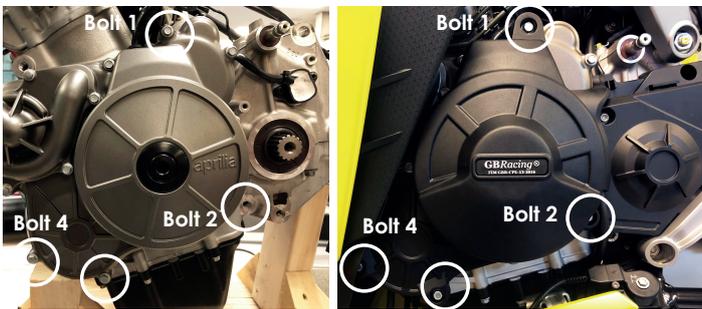
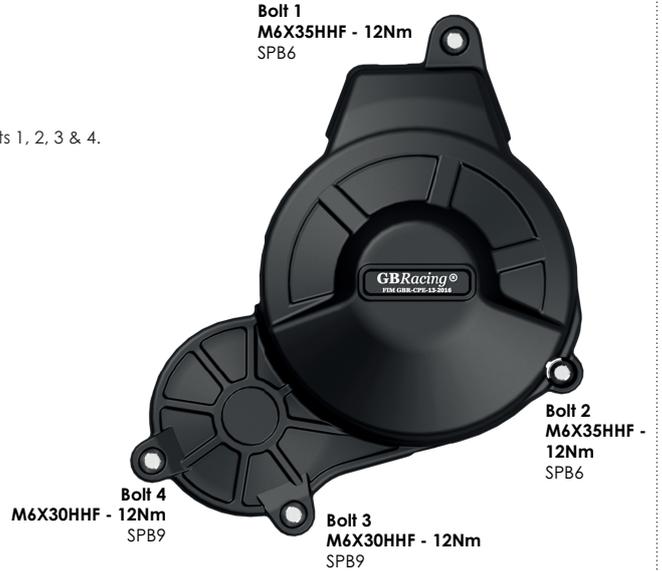
SECONDARY ALTERNATOR COVER
PART NO. EC-RS660-2021-1-GBR

- 1 Remove / loosen lower fairing or belly pan.
 - 2 Remove 4 existing bolts from the stock alternator cover, shown as position bolts 1, 2, 3 & 4.
 - 3 Place the secondary alternator cover over the stock cover.
 - 4 Assemble 4 replacement bolts loosely in the correct position as shown.
 - 5 Tighten bolts to a Torque of 12Nm as per Manufacturer's recommendations.
 - 6 Replace / tighten lower fairing or belly pan.
- DO NOT OVERTIGHTEN.

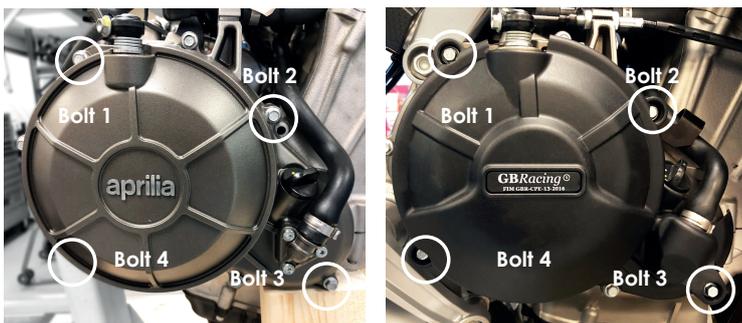
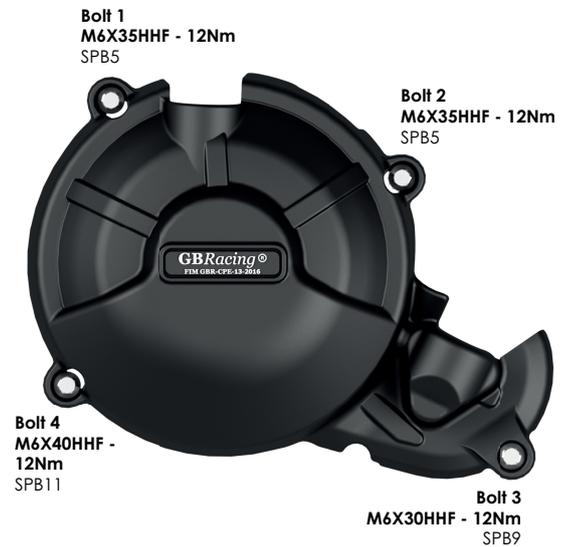
SECONDARY CLUTCH COVER
PART NO. EC-RS660-2021-2-GBR

- 1 Remove 4 existing bolts from the stock clutch cover, shown as position bolts 1, 2, 3 & 4.
 - 2 Place the secondary clutch cover over the stock cover.
 - 3 Assemble 4 replacement bolts loosely in the correct position as shown
 - 4 Tighten bolts to a Torque of 12Nm as per Manufacturer's recommendations.
- DO NOT OVERTIGHTEN.

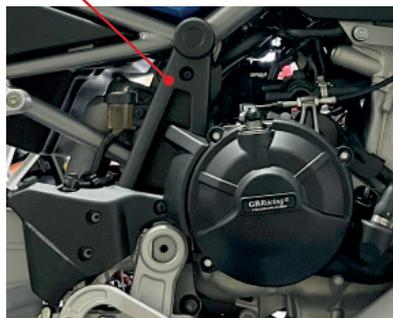
FIG 1: Plastic chassis cover

- 1 Remove the plastic chassis cover before fitting the clutch cover and reinstall after. **See FIG 1.**
- 2 Remove the top bolt of the exhaust guard to allow the guard to drop forward to allow fitment of the clutch cover. **See FIG 2.**

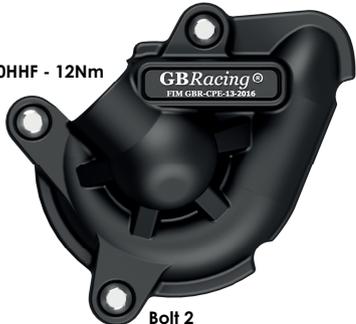
SECONDARY WATER PUMP COVER
PART NO. EC-RS660-2021-5-GBR

- 1 Remove fairing.
- 2 Remove the 3 existing bolts from the stock water pump cover in this order:
Bolt 1, 3 and then Bolt 2 – Bolt 2 last as this is the drain bolt.
- 3 Place the Secondary water pump cover over the stock cover.
- 4 Replace Bolt 2 first limiting fluid loss: Assemble the bolt loosely in the correct position as shown using the two supplied copper washers - see **Fig.1 for Bolt position 2**
- 5 Assemble the remaining two replacement Bolts 1 & 3 loosely in the correct position as shown
- 6 Tighten bolts to a Torque of 12Nm as per Manufacturer's recommendations.
 DO NOT OVERTIGHTEN.
- 7 Replace fairing and check coolant level.

Bolt 1
 M6X50HHF - 12Nm
 SPB2

Bolt 3
 M6X50HHF - 12Nm
 SPB2

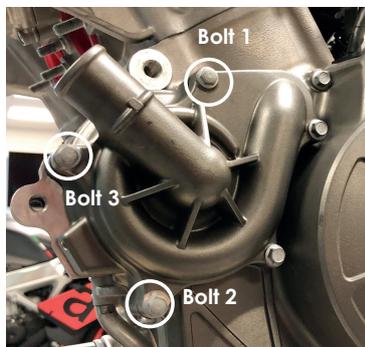
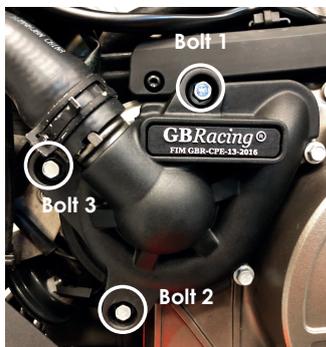
Fig. 1

Bolt 2
 M6X50HHF - 12Nm
 SPB2
 + 2 supplied copper washers
 (see Fig.1)
